**Development of a CFRP System to Provide Continuity in Existing  
Reinforced Concrete Buildings Vulnerable to Progressive Collapse**

**Dissertation**

The University of Texas at Austin

**August 2007**

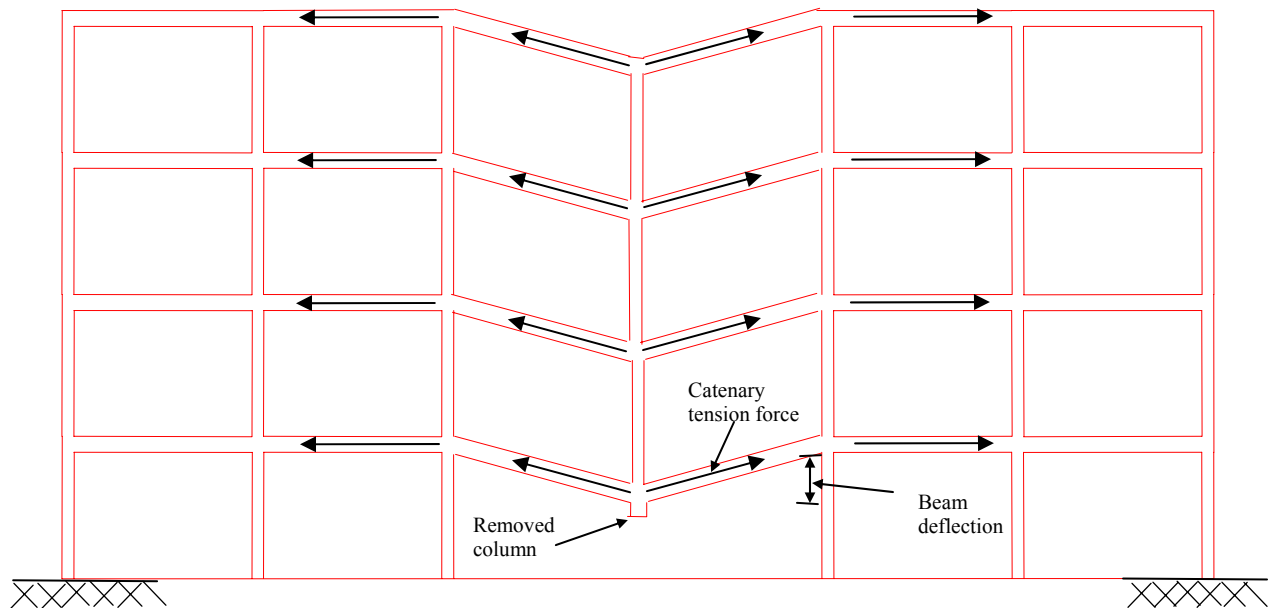
**Figure 1-1** Catenary action in a reinforced concrete frame

The objective of this research is to develop strengthening procedures using CFRP materials to reduce vulnerability to progressive collapse in existing reinforced concrete buildings. If the column support between spans of a reinforced concrete frame is removed accidentally or by a blast, the lack of continuity of reinforcement may cause progressive collapse. While the CFRP retrofit may not be able to save the building from significant damage, it may be able to limit the progression of the collapse and save lives and reduce injuries. This research focuses on retrofitting the beams in a reinforced concrete building to provide sufficient continuity to reach catenary action. The catenary action may allow the beam to carry vertical loads at large displacements if a supporting column were removed, Figure 1-1.

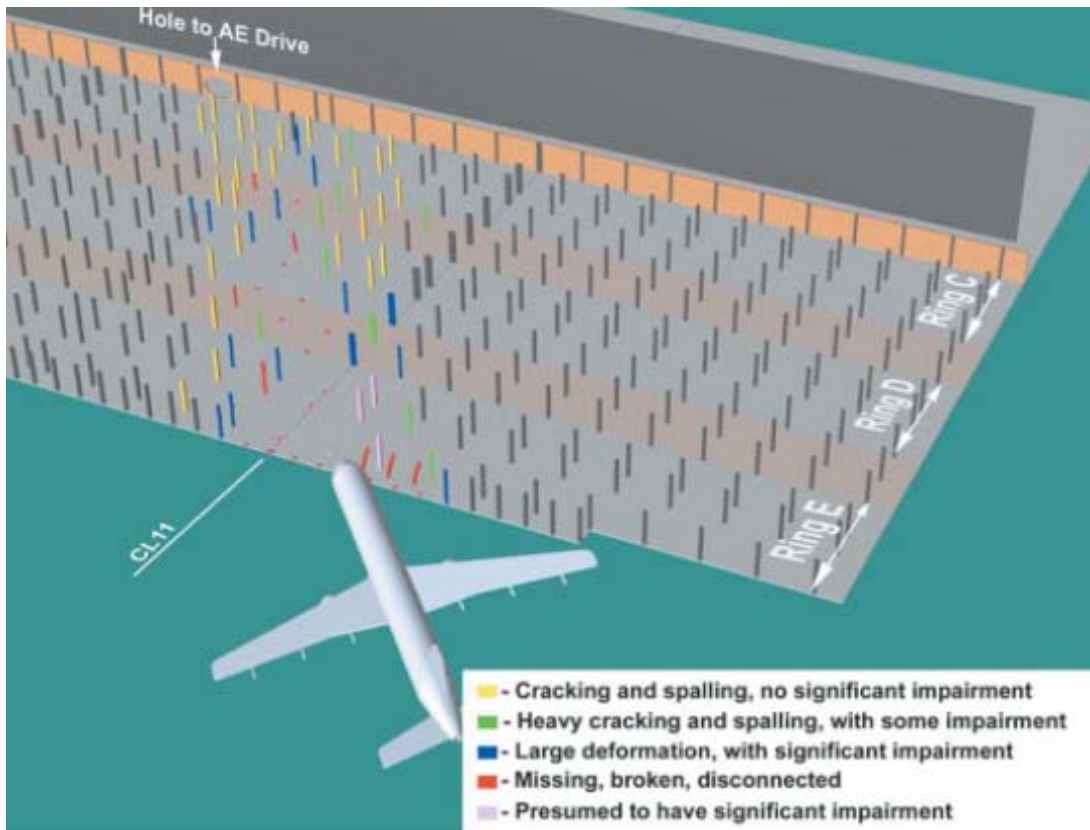
**Figure 2-7** Damage to first floor columns [Mlakar et al., 2003]

The survival of the Pentagon building demonstrates the capacity a reinforced concrete building to withstand catastrophic loads if designed with significant redundancy and continuity.

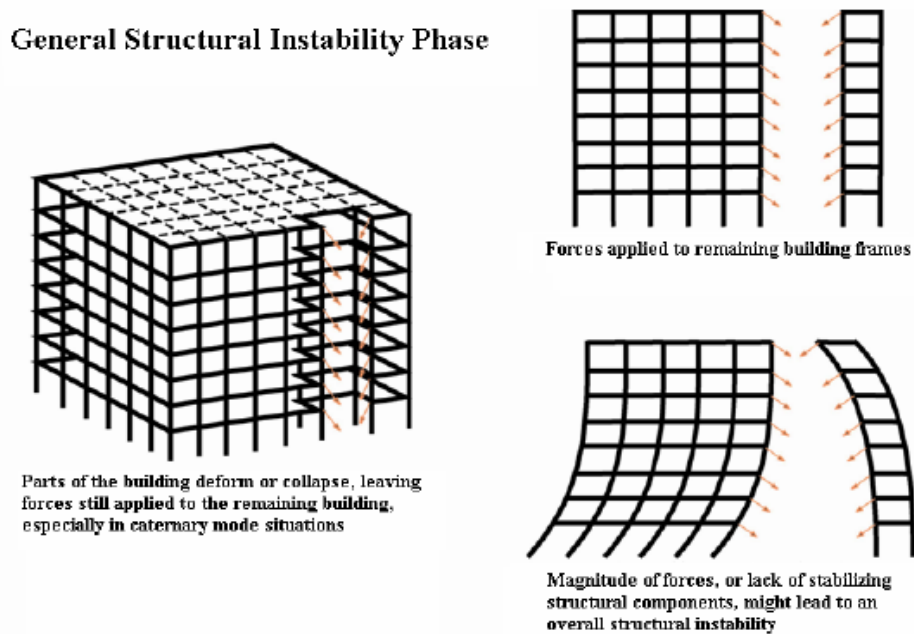
**Figure 2-12** Forces on structure due to catenary loads [NIST, 2007]

factors. The inelastic analysis can also include geometric non-linearity, such as tension membrane or catenary action. However, the relative advantages and disadvantages of a catenary system that may hold a floor up compared to one that would break away to prevent damage to the rest of the structure must be evaluated, Figure 2-12. The acceptance criteria are based on member deformation limits. For example, GSA requires a RC beam to have a rotation less than 6 degrees or 0.105 radians. DoD deformation requirements are similar. Both guidelines also include procedures for dynamic analysis of a structure.

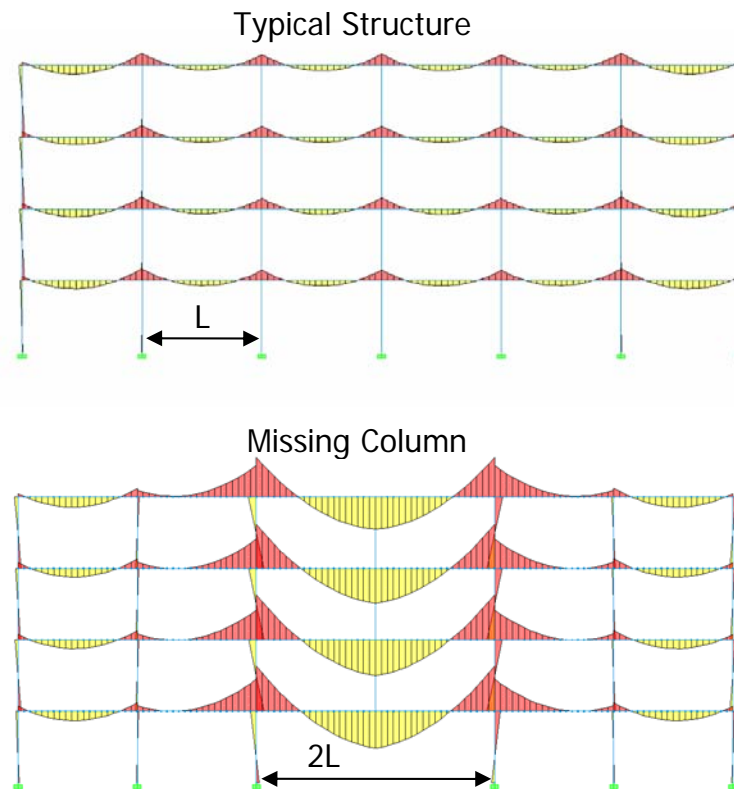
**Figure 2-15** Change in bending moment diagram due to loss of column

In order to resist progressive collapse, a structure must be able to survive the loss of a primary structural component without additional collapse. The loss of an exterior non-corner column in a reinforced concrete building is considered in this research. For a typical reinforced concrete building, the double span condition created by the loss of a column can be difficult to accommodate. As seen in Figure 2-15, the bending moment significantly increases (approximately 4 times) due to the double span. Furthermore, the moment over the missing column reverses direction, positive where the beam was designed for negative moment. The reversal and increase in moment can be difficult for a beam to accommodate through flexure.

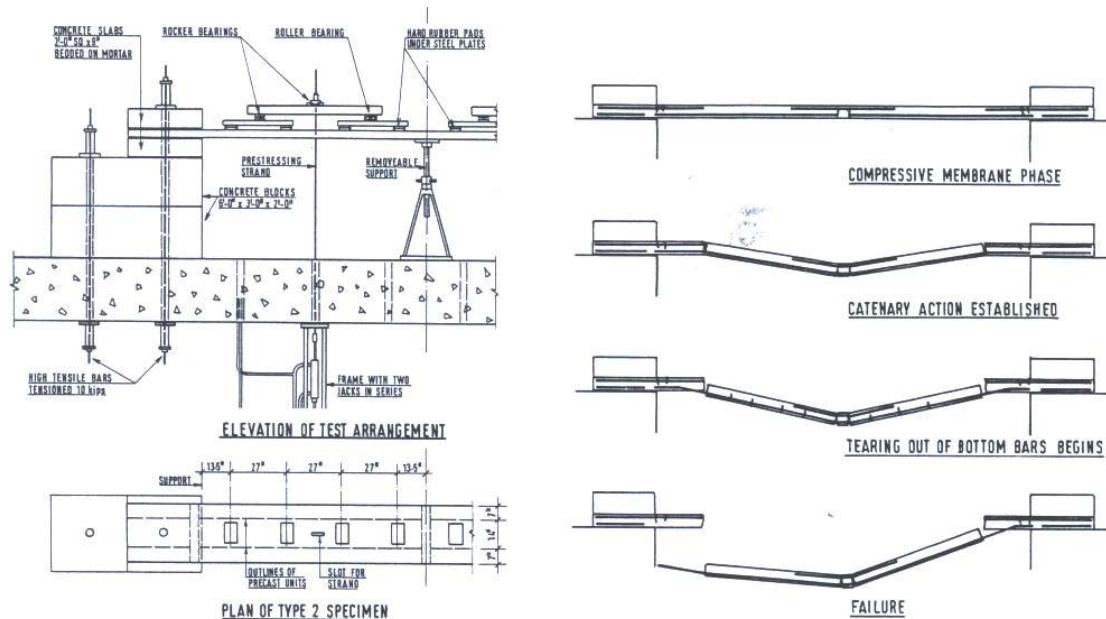
**Figure 2-20** Catenary tests of precast floor strips [Regan, 1975]

In his conclusions Regan stated “successful development of a catenary action requires that the members in question possess not only tensile strength but also ductility, which is largely determined by the detailing of the longitudinal reinforcement.” The ductility he mentions pertains to, in part, the ability of the concentrated rotation locations (hinges) to not fracture the rebar before catenary action is developed.

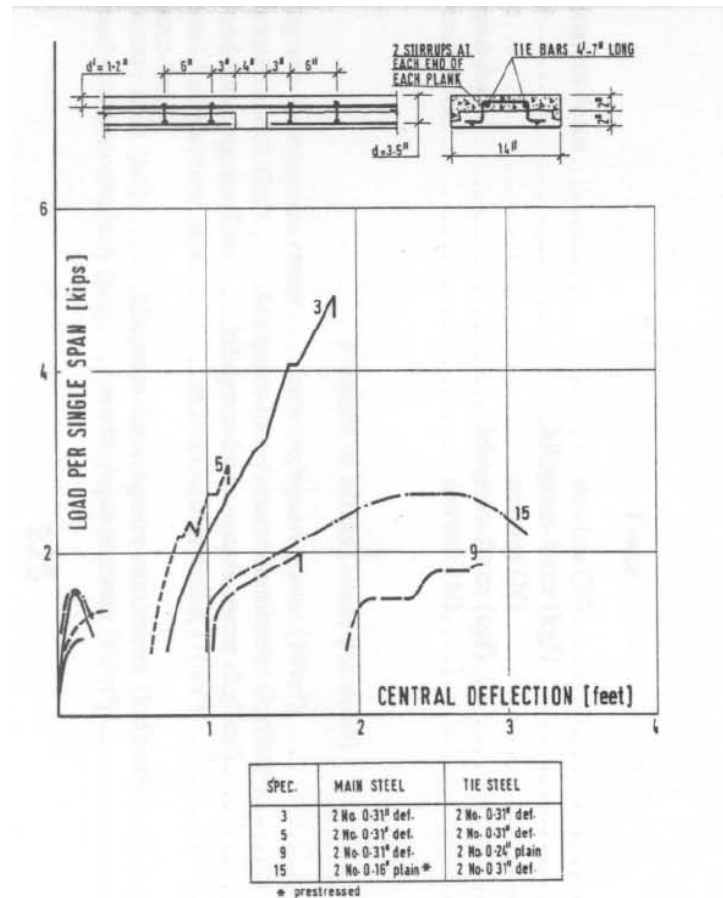
**Figure 2-21** Results of catenary tests of precast floor strips [Regan, 1975]

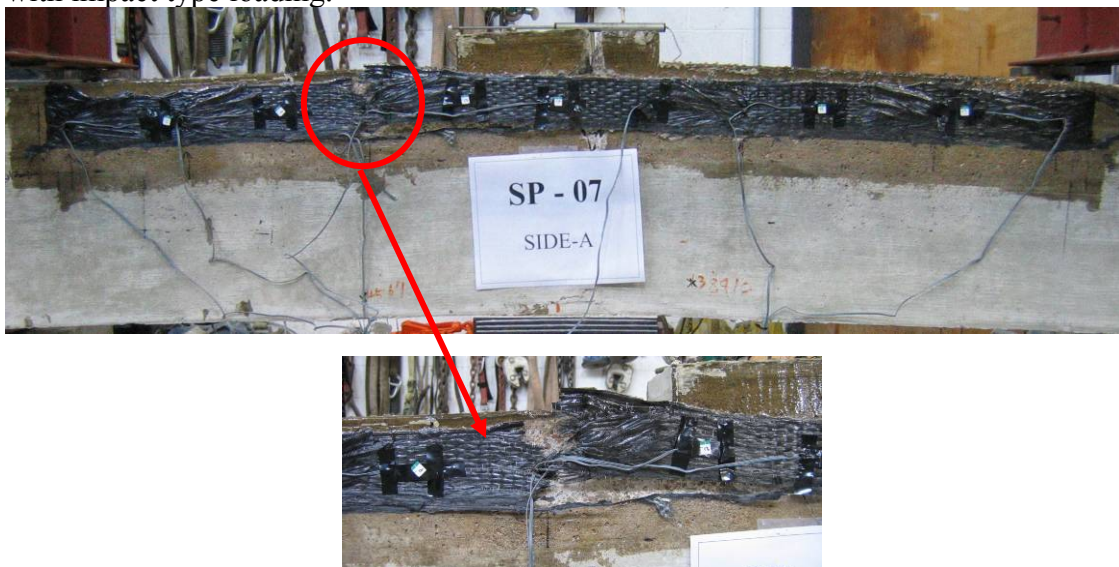
**Figure 3-28** Fracture of CFRP with anchors [Kim, 2006]

Kim (2006) used carbon fiber anchors and U-wraps to examine the rehabilitation of poorly detailed RC structures, Figure 3-28. He applied CFRP to the sides of beams and found the anchors can increase the capacity of the rehabilitation by as much as 1.75 (anchors alone) to 2.2 (anchors with U-wraps) times. Kim is currently conducting tests to evaluate the effect of suddenly applied loads on the CFRP capacity. Early results indicate that CFRP anchors are able to develop the full tensile capacity of the CFRP sheet with impact type loading.

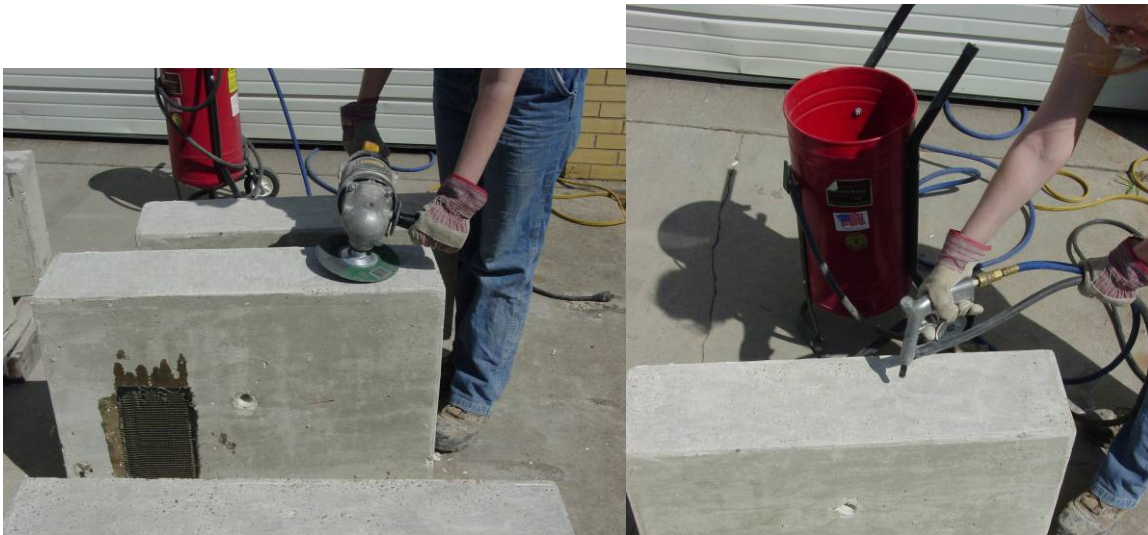
**Figure 3-31** Grinding and sandblasting surface preparation

The first step in applying the CFRP is preparing the surface of the concrete. ACI 440 recommends that the concrete surface be freshly exposed and be free of all loose or unsound materials. The surface preparation can be accomplished by abrasive techniques such as sandblasting. ACI also recommends a concrete surface profile (CSR) of 3 as defined by the ICRI surface profile chips with local out of plane variations less than 1/32 in. For the tests in this report, the surface preparation was accomplished by first grinding the surface using a concrete grinding disk and then sandblasting the surface, Figure 3-31.

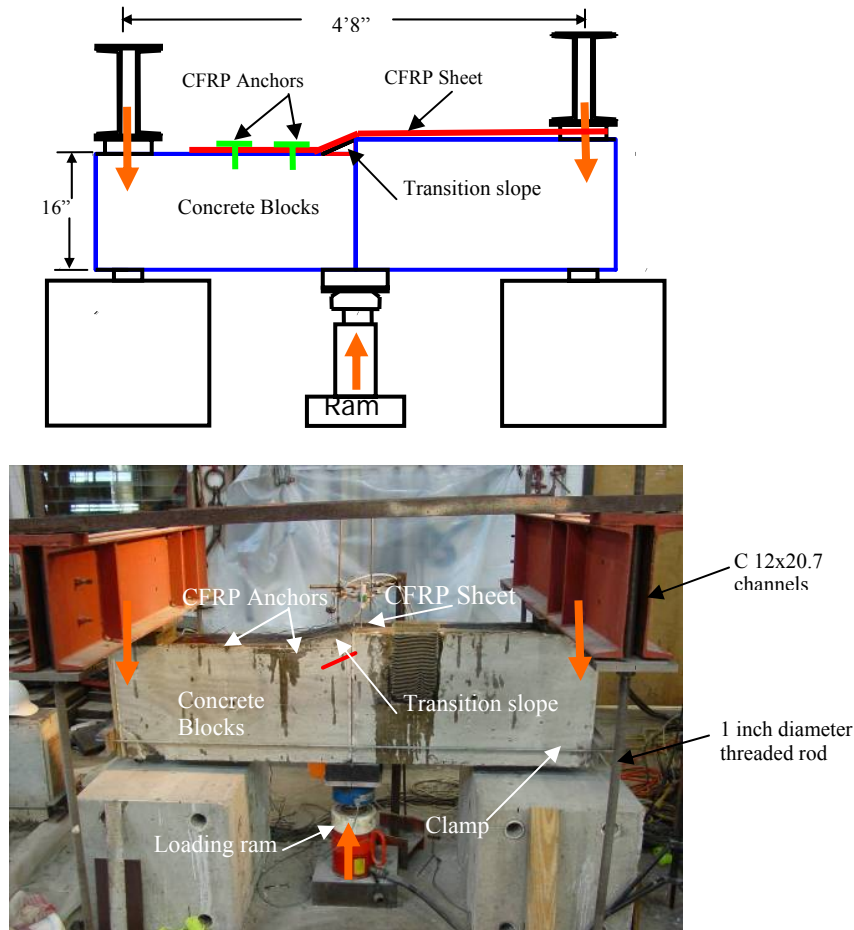
**Figure 4-3** Test setup

reinforcing bars. The tests with a height transition simulated the case of providing continuity through the positive moment reinforcing bars.

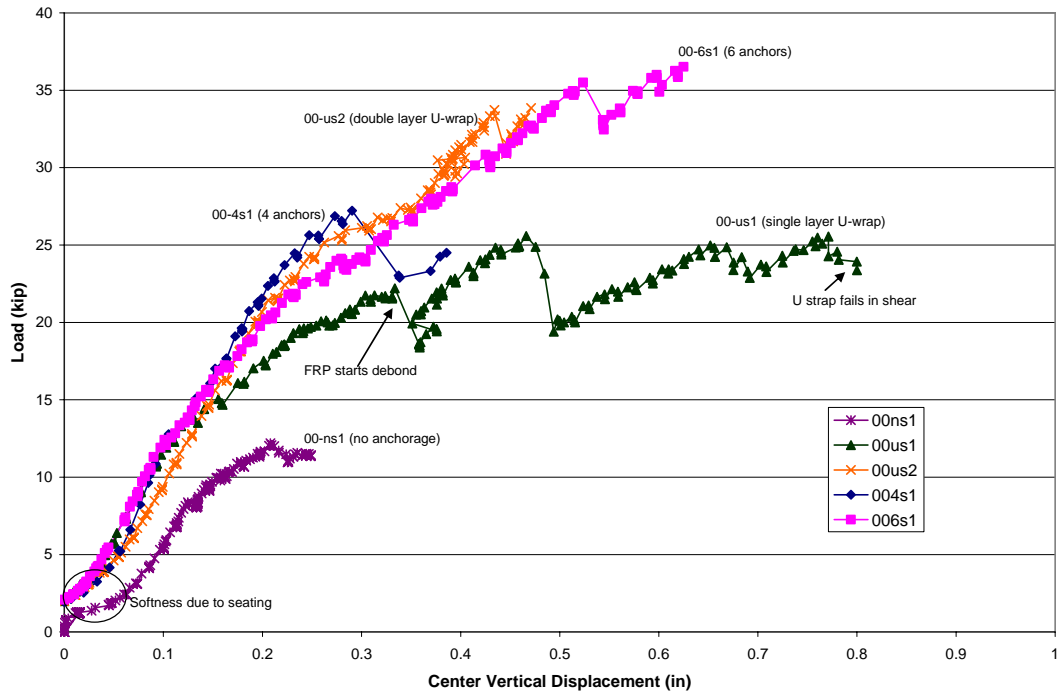
**Figure 4-15** Deformation capacity of various retrofits

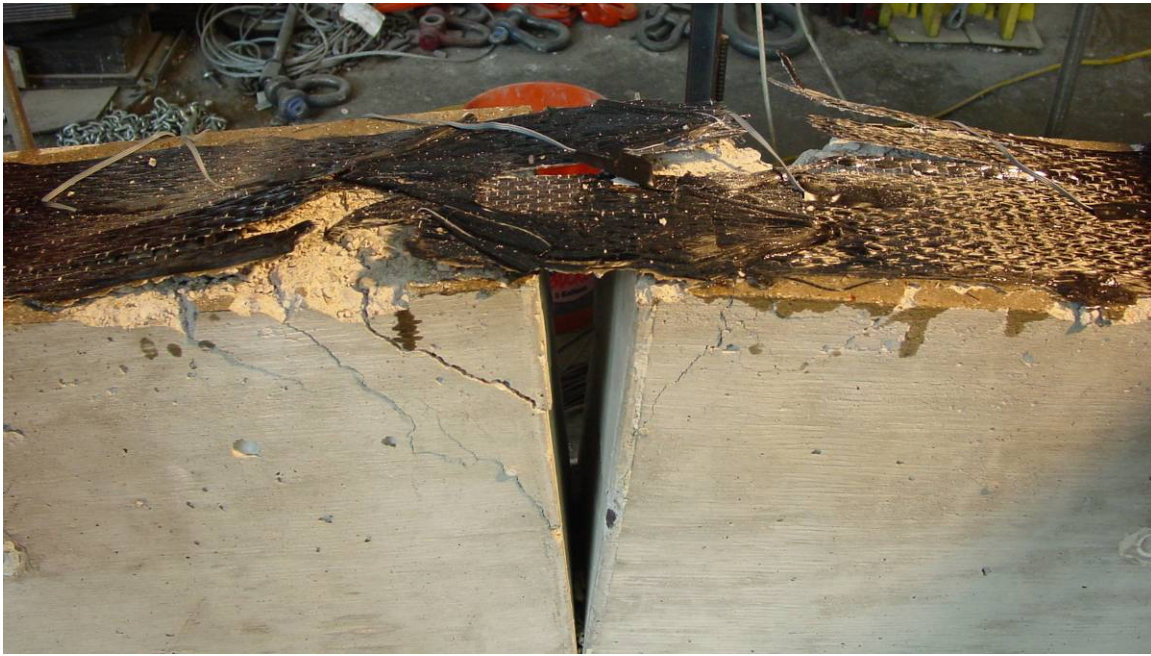
**Figure 4-18** Failure by FRP fracture of retrofit with two anchors per row (00-4s2)

Two  $\frac{1}{2}$  in. diameter anchors in each row increased the tension in the CFRP sheet at failure to 79% of ultimate tensile capacity (00-4s2). Although the failure occurred by CFRP fracture, the specimen only reached 25 k of tension in the CFRP sheet. The reduced tension at fracture may be due to the fact that the fracture occurred along half of the CFRP sheet on one side of the block then along the other half on the other side of the block, Figure 4-18. The splitting of the fracture between two blocks could be indicative of a lack of uniform stress distribution across the CFRP sheet, with fracture occurring on one side followed by fracture on the other side. The reduced capacity could also be due to the fact that SCH-41 fabric was used in the anchors rather than SCH-35 in the previous tests (see Section 4.3.2.2).

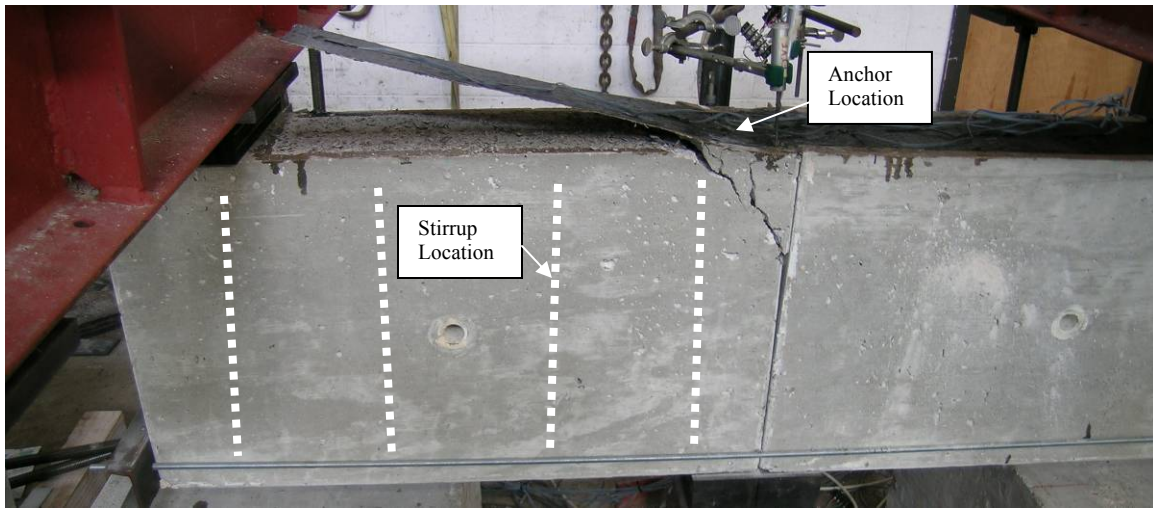
**Figure 4-22** Failure by concrete fracture and debonding for retrofit with one row of two anchors (00-2s1)

Two tests had undesirable failure modes. The first had two anchors in one row (00-2s1). Because both anchors were located in front of the first stirrup, the corner of the concrete block simply fractured off and the rest of the CFRP sheet debonded at 37% of ultimate, Figure 4-22. The other test consisted of two rows of two anchors and used in 12 in. high blocks that had no stirrups (00-4g1). The concrete blocks failed in shear at 63% of the ultimate tensile capacity, Figure 4-23. The results of these two tests illustrate the importance locating the anchors where forces can be transferred into the concrete and of ensuring sufficient shear capacity in members that are strengthened flexurally.

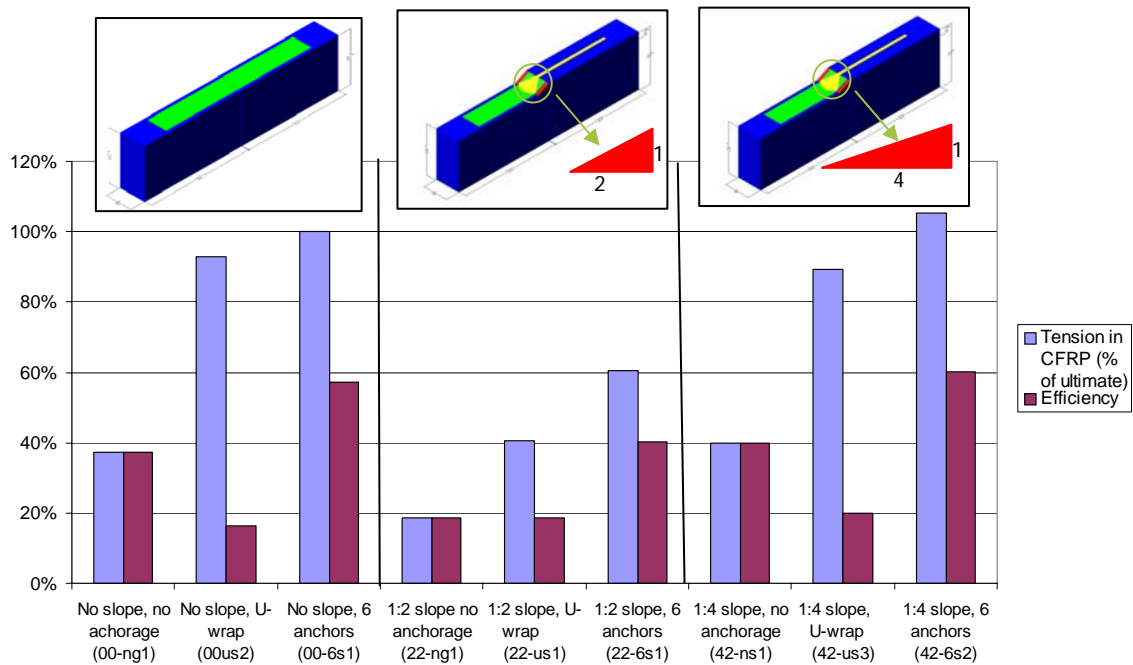
**Figure 4-24** Effect of slope of transition

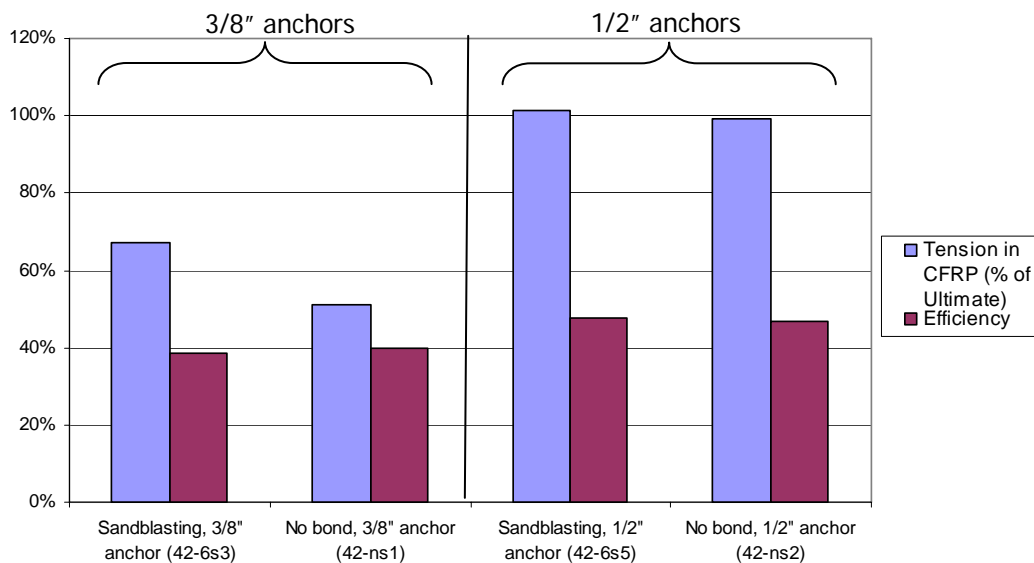
**Figure 4-28** Effect of surface preparation

The performance of 42-6n1 and 42-6n2 indicates that although bond to the concrete can supplement the maximum load, when the anchors are large enough, the anchors can transfer all the tensile force from the CFRP sheet into the concrete without any CFRP bonding to the concrete. Furthermore, even in tests with anchors where bond was provided between the CFRP and the concrete, the CFRP sheet often debonded from the concrete prior to reaching maximum load. Therefore, the use of anchors may reduce the need for extensive surface preparation because CFRP bond to the concrete is no longer critical to achieving the desired capacity of the CFRP retrofit. Anchors may increase the reliability of CFRP retrofits by reducing uncertainties relating to the quality of the surface preparation and bonding strength. However good quality control is still needed to realize maximize performance for the CFRP sheets.

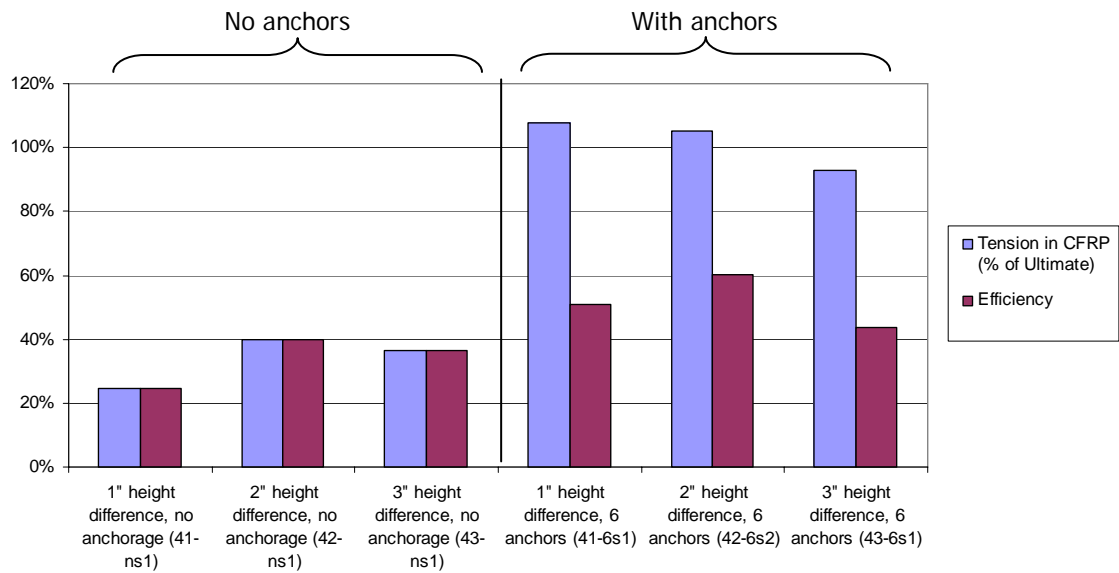
**Figure 4-30** Effect of height difference

In the last set of tests, the effect of the height difference (1, 2, and 3 in.) in the height transition with a 1:4 slope was studied, Figure 4-30. When  $\frac{1}{2}$  in diameter anchors were used, the full capacity of the CFRP sheet was reached regardless of the height difference. With a 1 in. height difference failure occurred by FRP fracture at 108% of ultimate tensile capacity (41-6s1), Figure 4-31. With a 3 in. height difference failure occurred by FRP fracture at 93% of ultimate tensile capacity (43-6s1), Figure 4-32. The differences between the failure loads may be due to the fact that for a 1:4 slope and a 3 in. height difference the transition ramp was 12 in. long, whereas for a 1 in. height difference it was only 4 in. long. The length of the transition ramp on a short concrete block (24 in.) may have impacted the failure of the CFRP sheet. When unanchored, less than 45% of the ultimate tensile capacity was reached in any test (41-ns1, 42-ns1, 43-ns1). Therefore, the amount of the height difference between surface levels of the CFRP did not significantly affect the capacity of the CFRP sheet when the sheet was anchored and a shallower than 1:4 transition slope was provided.

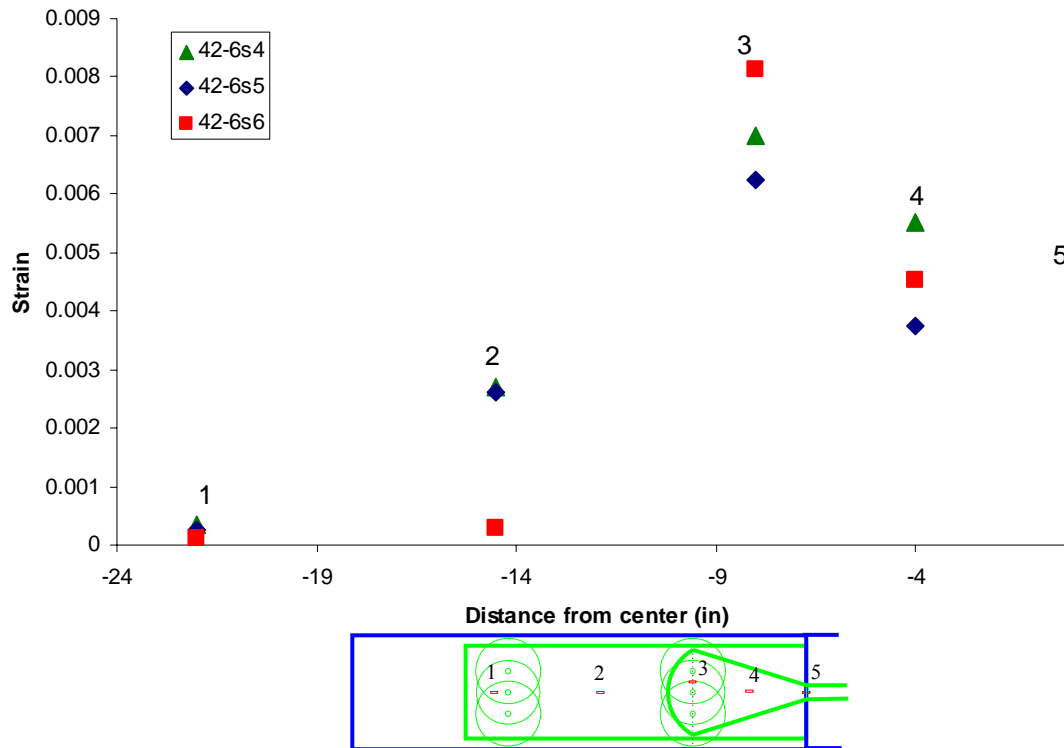
**Figure 4-35** Distribution of strains at CFRP fracture for tests with 6 anchors

bottom of the transition slope was difficult and the gages may not have recorded the actual maximum strain.

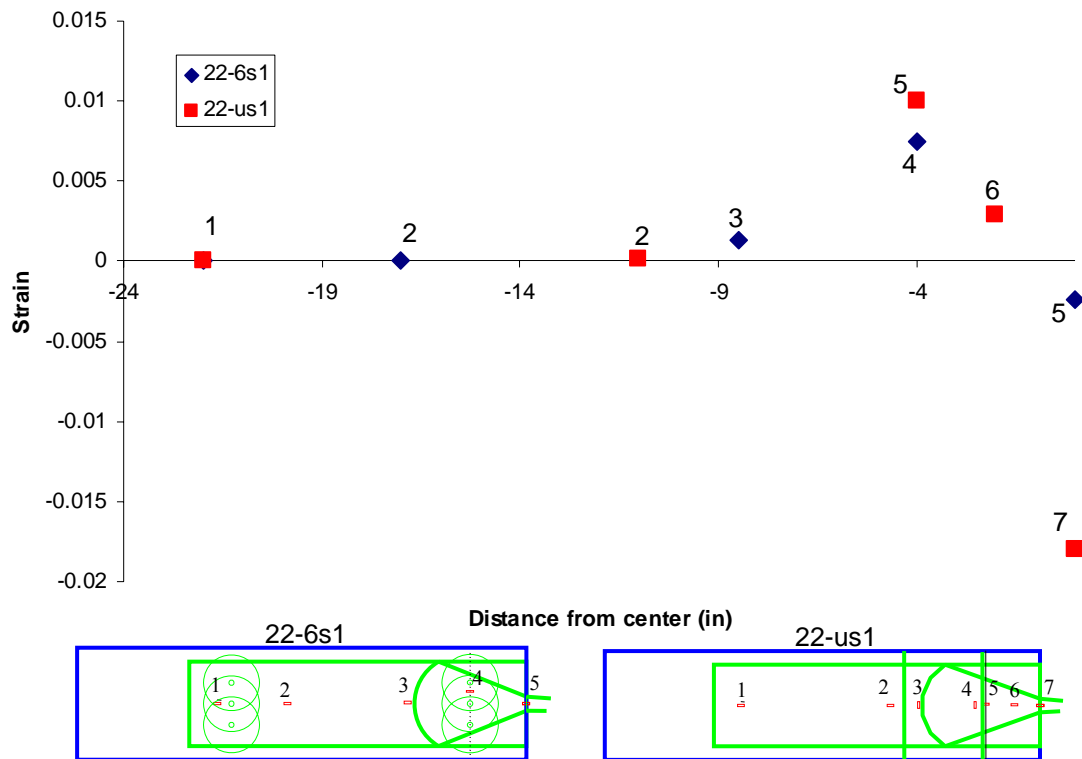
**Figure 4-36** Distribution of strains at CFRP fracture for tests with 1 to 2 transition slope

The strain reading for tests with a 1 to 2 transition slope are given in Figure 4-36. These strains indicate a higher strain at the bottom of the transition slope (0.007 and 0.01) but also a compressive strain at the top of the slope (-0.002 and -0.017). The compressive strains are caused by the concave bend of the CFRP at the top of the transition slope and the fact that the CFRP was bundled at that location causing a great amplification of the bend (strain gage was placed on top of CFRP bundle), Figure 4-37. The compressive strain is not likely the strain throughout the CFRP at that location, just the strain on top of the bundle.

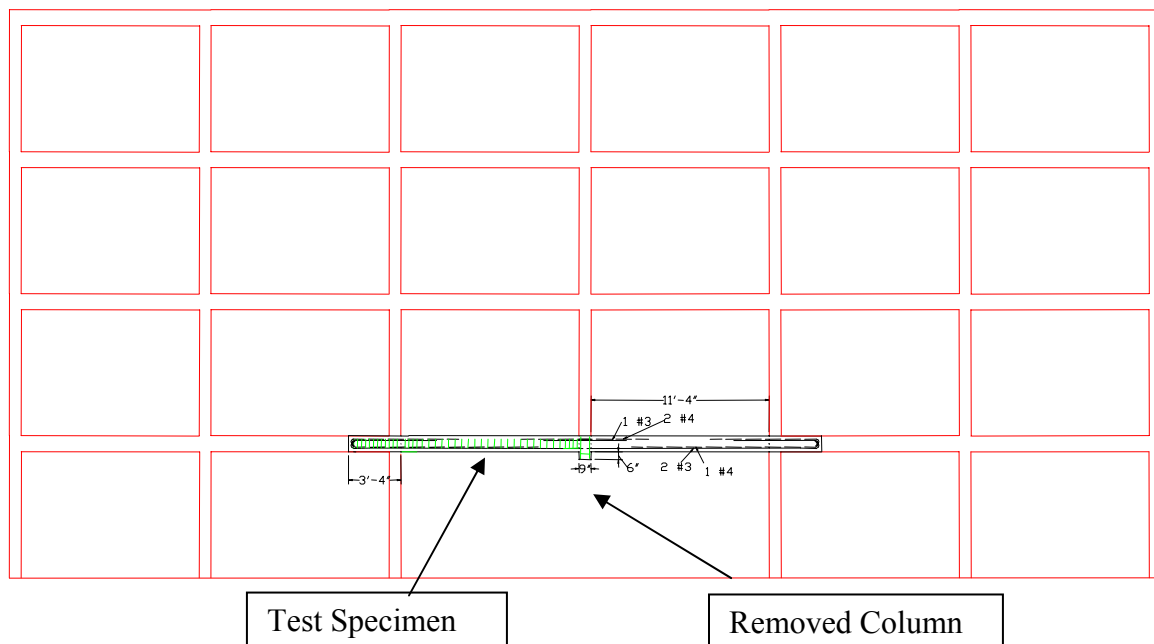
**Figure 5-3** Relationship of test specimen to prototype building

The tests were designed to simulate the behavior of adjacent spans after removal of a non-corner perimeter column. The relationship of test specimen to the full scale structure is shown in Figure 5-3. The 3 ft sections on the ends of the test specimen were designed to simulate the support from the rest of the structure. The support from the structure does not include the effect of the slab or the upper story column. During a blast event the slab may be damaged, or depending on the design may not be connected to the beam in such a way that it can resist vertical loads. The upper story column may not be able to resist tension loads depending on the splicing of the reinforcement. Therefore, the test specimen only considered the resistance of the beam itself.

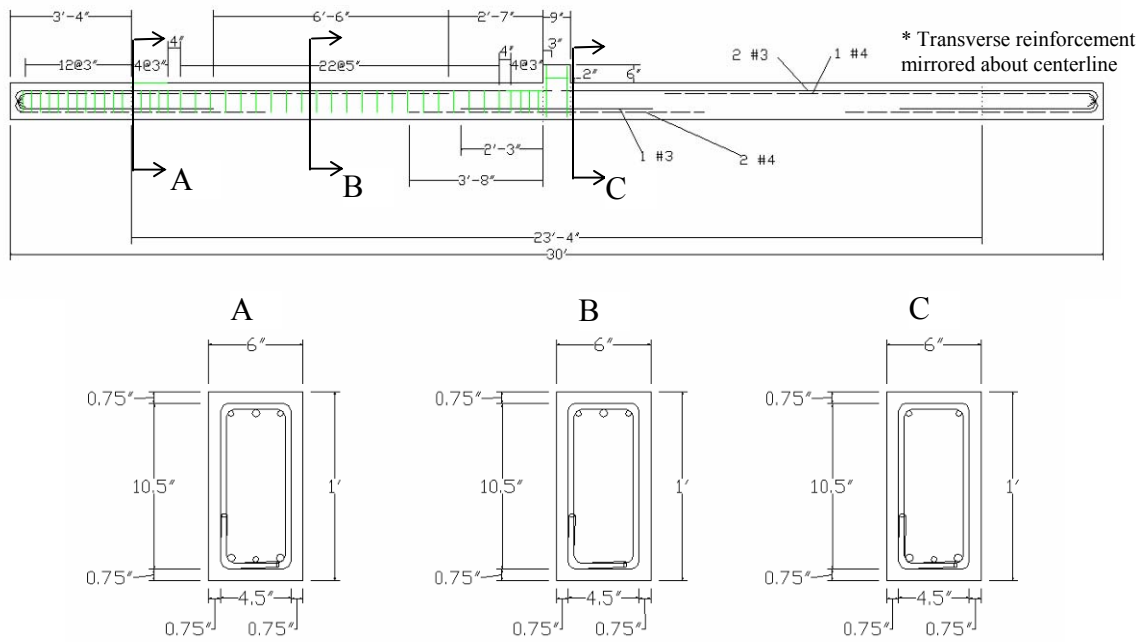
**Figure 5-4** Reinforcement design of test specimen (shown in test position)

The test specimen was half scale with a 12 in. by 6 in. cross section, 9 in. by 8 ½ in. column stub, and 30 ft length. The 30 ft length consisted of two half scale 12 ft spans and an additional 3 ft span on each end to provide restraint during testing. The reinforcement consisted of #3 (0.11 in<sup>2</sup>) and #4 (0.2 in<sup>2</sup>) reinforcing bars equivalent to half-scale versions of the prototype beam. The reinforcement for the beam design, shown in Figure 5-4 and Figure 5-5, is discontinuous in both the negative moment and positive moment regions. Cutoff locations for the reinforcement were based on typical building practice and adhere to the 1971 ACI code. The beam contained transverse reinforcement consisting of #3 stirrups with 90° hooks sufficient to prevent shear failure in the beam during testing and provide some confinement and additional ductility near the ends of the span. Although the level of shear reinforcement may be greater than typical 1970's practice, actual beams may be retrofitted to improve shear capacity if a deficiency exists. The column stub in the center of the beam represented the remnants of a removed column. The stub contained one # 3 stirrup located 3 in. above the positive moment rebar.

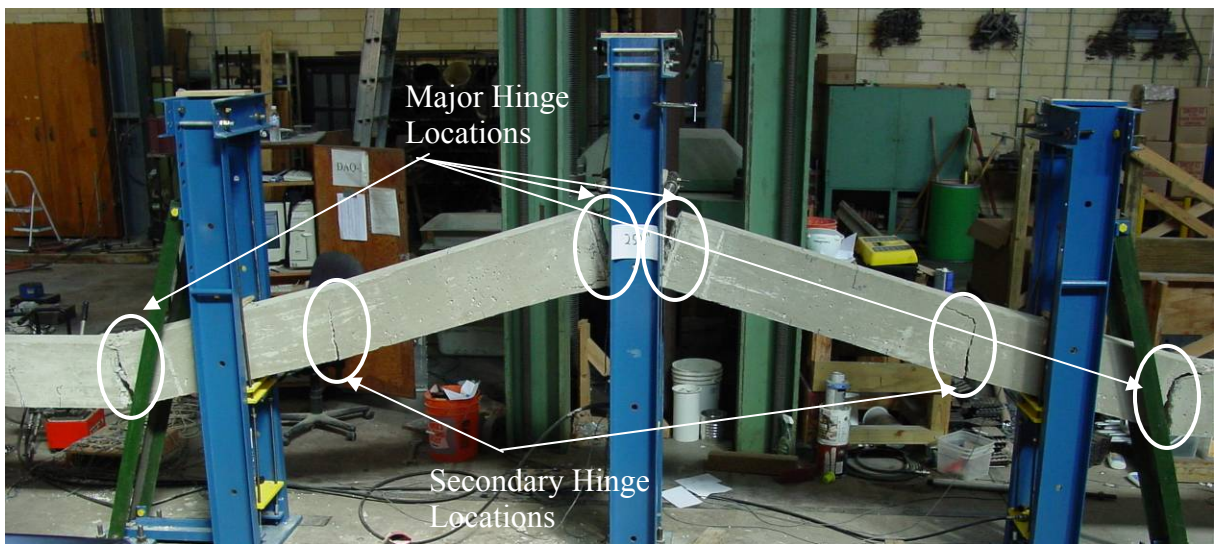
**Figure 5-19** Failure of specimen NR-2

The design of the beam provided extra capacity in the stirrups (#3 stirrups at 5 in. spacing with 90° hooks) due to scaling issues (smallest size of deformed rebar available was #3). If the design of the stirrups had been properly scaled, they may have not have been able to transfer the catenary tension loads between the positive to the negative moment reinforcement.

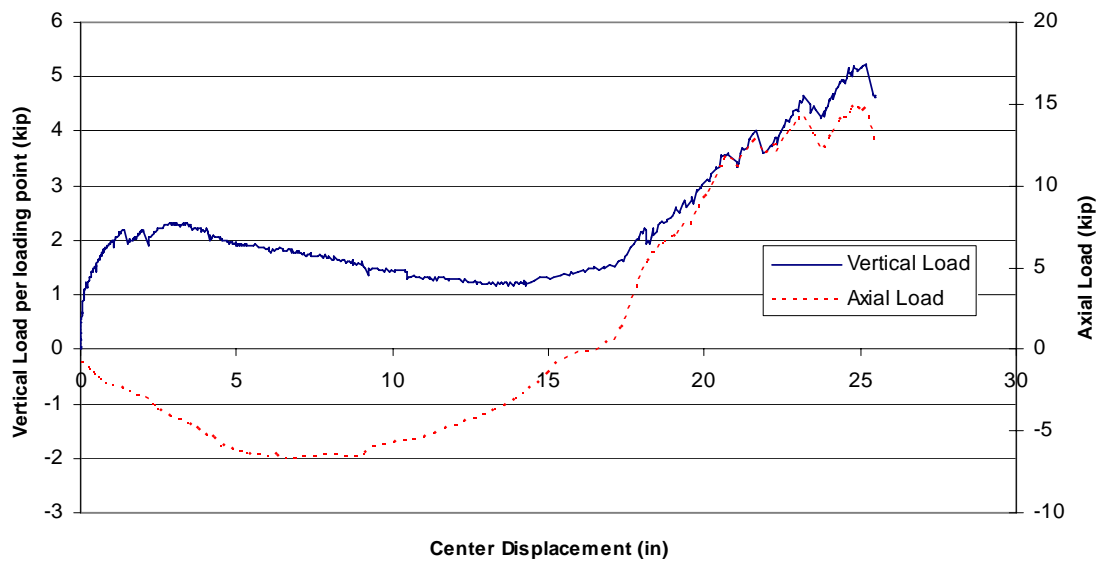
**Figure 5-20** Vertical and axial loads versus displacement for NR-2

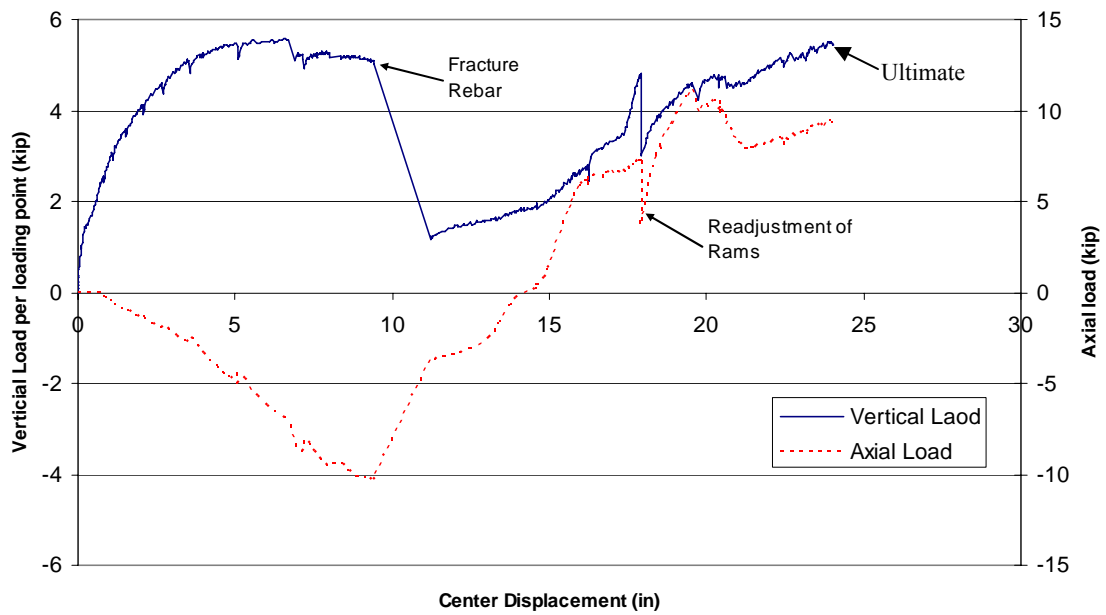
**Figure 5-26** Vertical and axial loads for PM-1

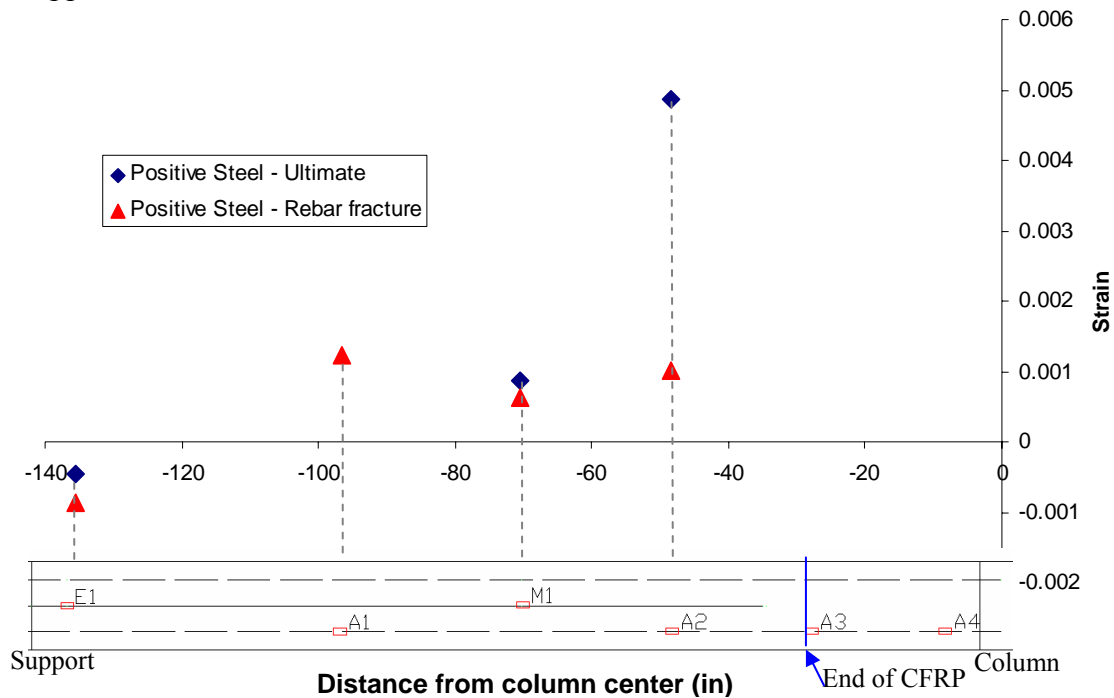
**Figure 5-27** Strains in positive moment steel for PM-1

The strains in the positive moment steel at rebar fracture and ultimate deflection are shown in Figure 5-27. Unfortunately, several of the gages were not working during the test and yielding and fracture of the positive moment rebar was not monitored. The maximum measured strain in the CFRP prior to fracture of the rebar was 0.005, Figure 5-28. At the same time, reading of 0.002 and 0.003 occurred at gages 2 and 7 just beyond the transition slope. When compared to the results from the anchorage tests, in which strains of around 0.008 at the bottom of the transition slope and 0.003 at the gage just beyond (gages 2 and 7) were measured, the strain in the CFRP just prior to rebar fracture indicate that the material was near its ultimate tensile capacity and was being used efficiently. After rebar fracture, the CFRP strains on the North side of the beam dropped due to the redistribution of moment.

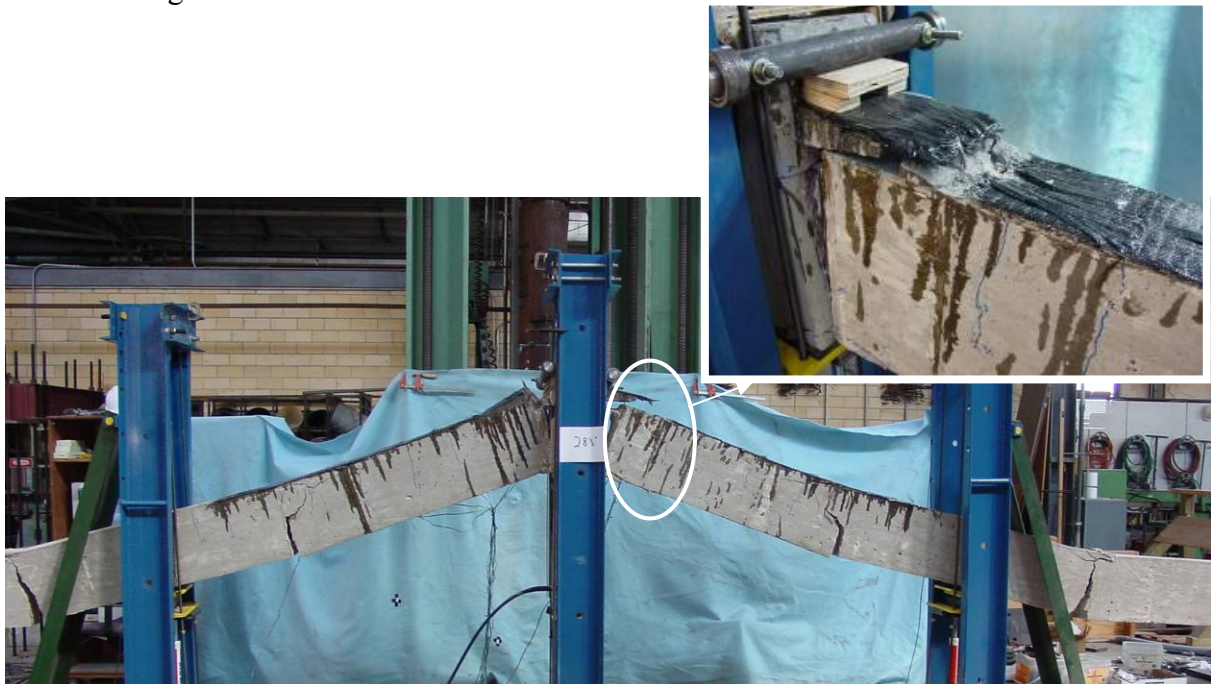
**Figure 5-31** Final state of PM-2

of the CFRP was not necessarily premature, but more CFRP was needed in the design to force the hinge to form at the end of the CFRP sheet.

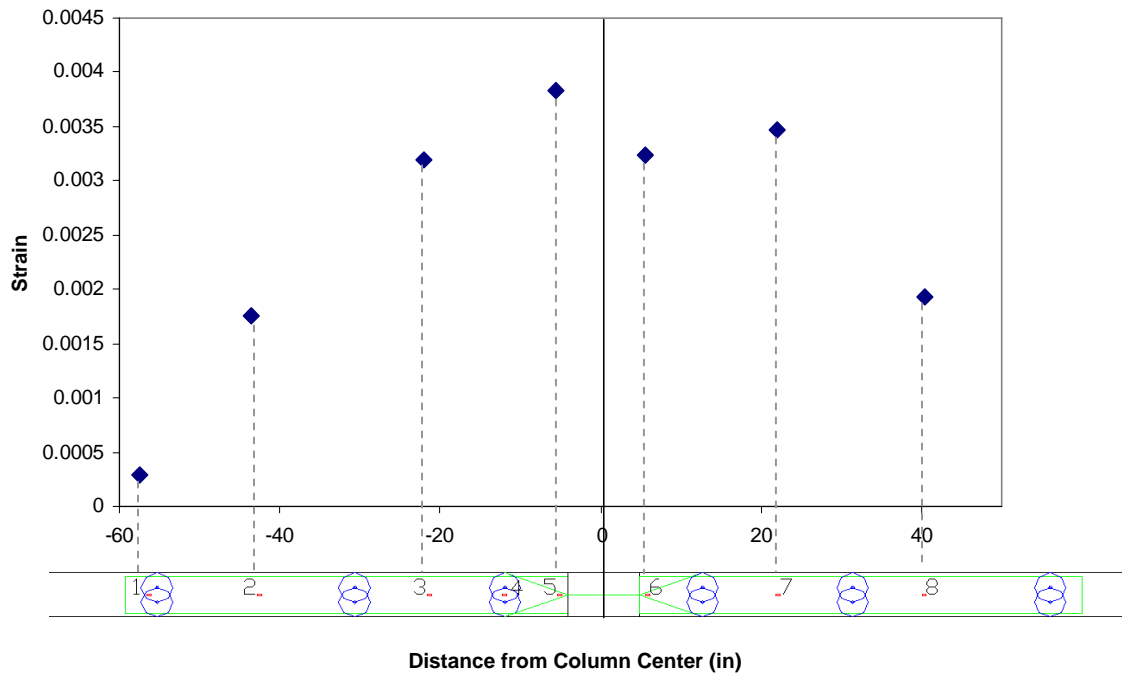
**Figure 5-33** Strain in CFRP prior to fracture for PM-2

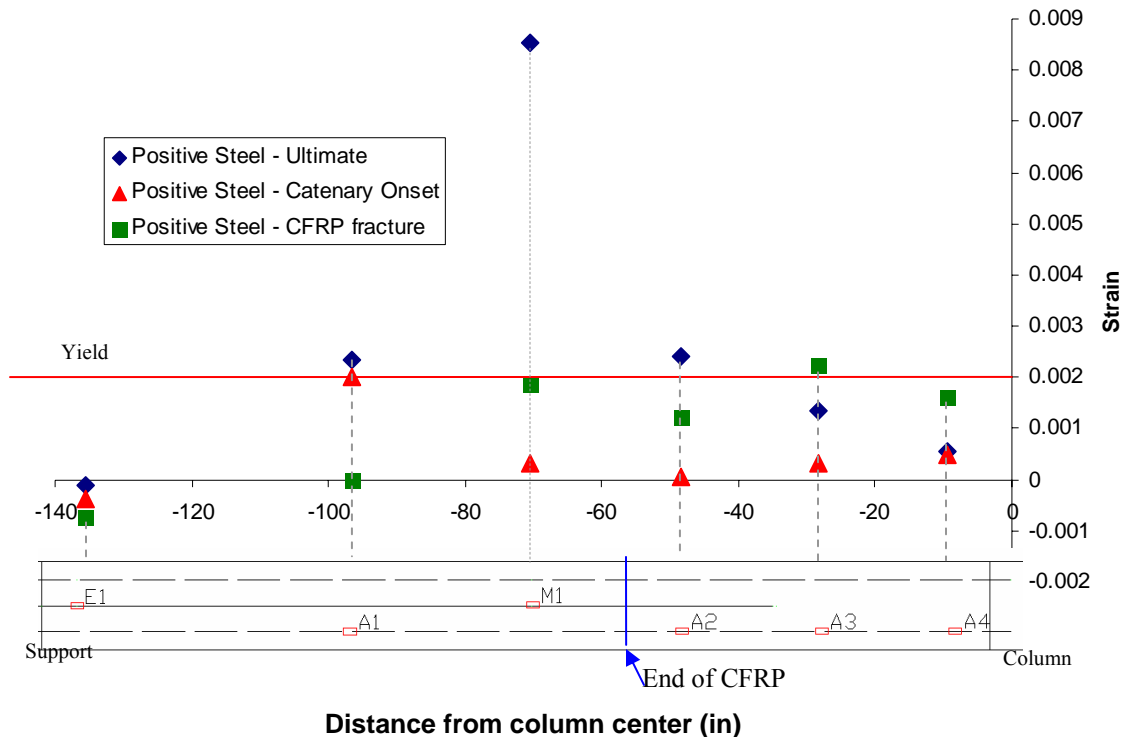
**Figure 5-34** Strains in positive moment steel in PM-2

Although the 6.8 k per loading point is not 10 k per loading point recommended by the GSA to resist progressive collapse, if the anticipated dead and live loads were less so that  $2(DL + 0.25LL)$  requirement was less than 10 k per loading point (beam was over-designed) and the dynamic increase factor of 2 reduced (see Chapter 2) the 6.8 k that could have been reached by the positive moment retrofit could be enough to resist progressive collapse.
